NATIONAL DAM SAFETY PROGRAM. VALLE LAKE DAM (MO 30438), MISSISS-ETC(U)

VALLE LAKE DAM
JEFFERSON COUNTY, MISSOURI
MO. 30438

**PHASE I INSPECTION REPORT
NATIONAL DAM SAFETY PROGRAM**

PREPARED BY: U. S. ARMY ENGINEER DISTRICT, ST. LOUIS

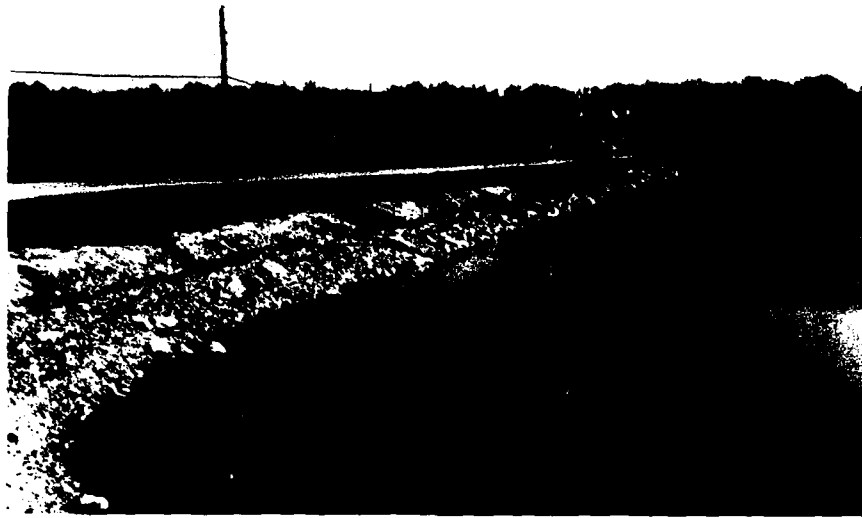
Photo 1 - View of the upstream slope from the left abutment.

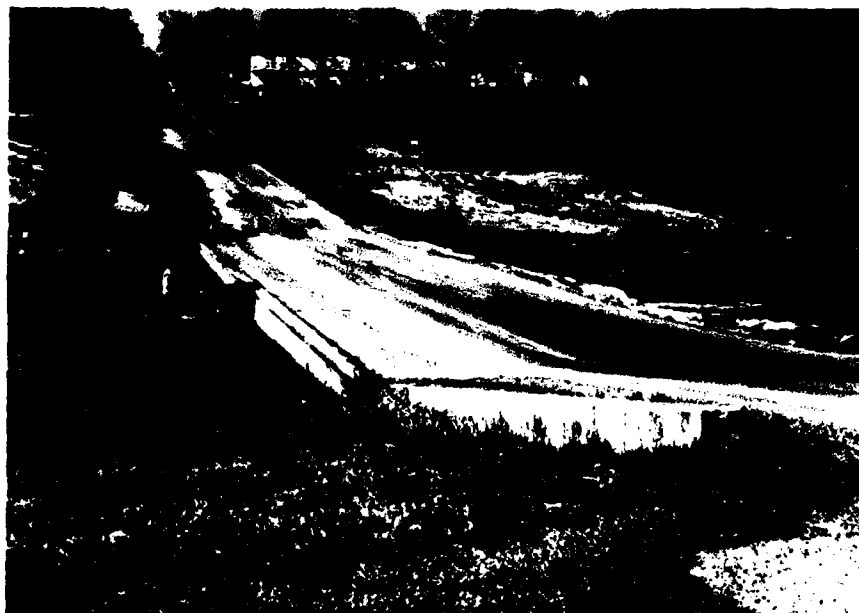
Photo 6 - View of the principal spillway drop inlet and emergency spillway broad-crested weir looking toward the left abutment.

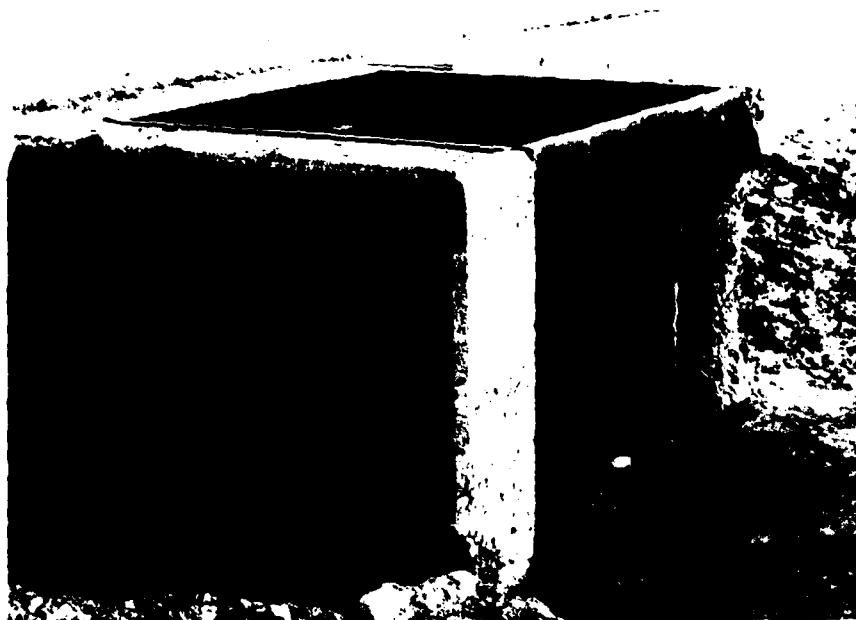
The front edge of the right sidewall has partially disintegrated into the stoplog slot (see Photo 7). No reinforcement was evident. The remaining concrete surfaces appeared stable with minor weathering observed. A small amount of debris was seen in the bottom of the drop inlet; however, the spillway was operating on the day of the inspection. It appears that some repair work was done

1. The disintegration of the principal spillway right sidewall does not presently affect the safety of the dam. Further deterioration will preclude the use of the stoplog slot and the reservoir regulation that the drop inlet provides will be lost. The complete failure of the wall could impair the functioning of the spillway and thus imperil the safety of the dam.

Photo 7 - Close-up view of the principal spillway drop inlet showing the concrete deterioration of the stoplog slot.

1. Further investigation of the three areas of seepage and possible seepage observed along the downstream slope should be undertaken to determine the seriousness of the condition. The investigation should be carried out under the direction of a qualified professional engineer and repairs made as required.
2. The damage to the principal spillway drop inlet sidewall should be repaired.
